# Advanced Reconductoring as a First Step Grid Capacity Expansion

Reconductoring with Advanced  
Conductors on Existing Structures

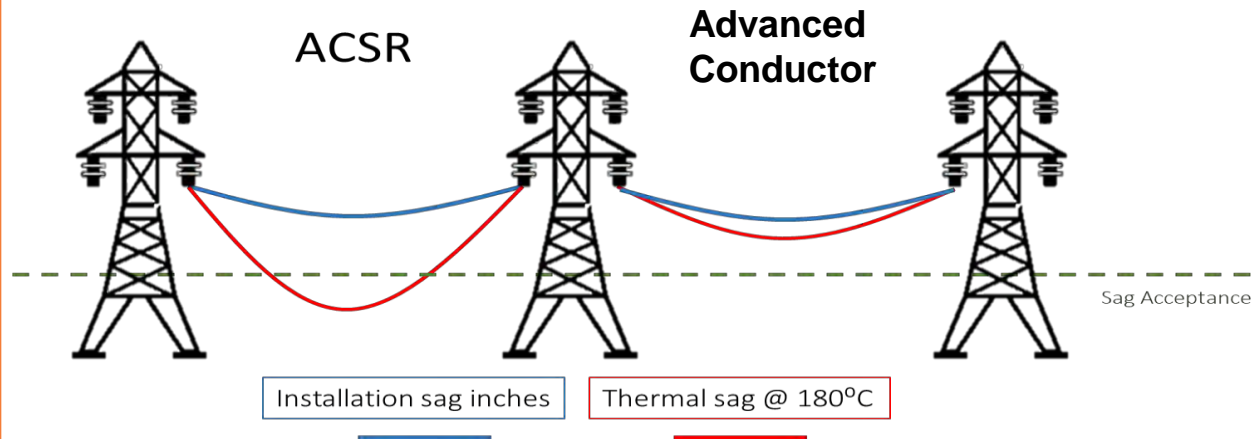
## Advanced vs. Conventional

- Replace steel and hard aluminum with carbon and annealed aluminum
- More aluminum that is more efficient equals:
  - 2x capacity capability
  - More efficient (~30% lower resistance)
- Much lower thermal expansion means 50% less thermal sag
- Corrosion resistant

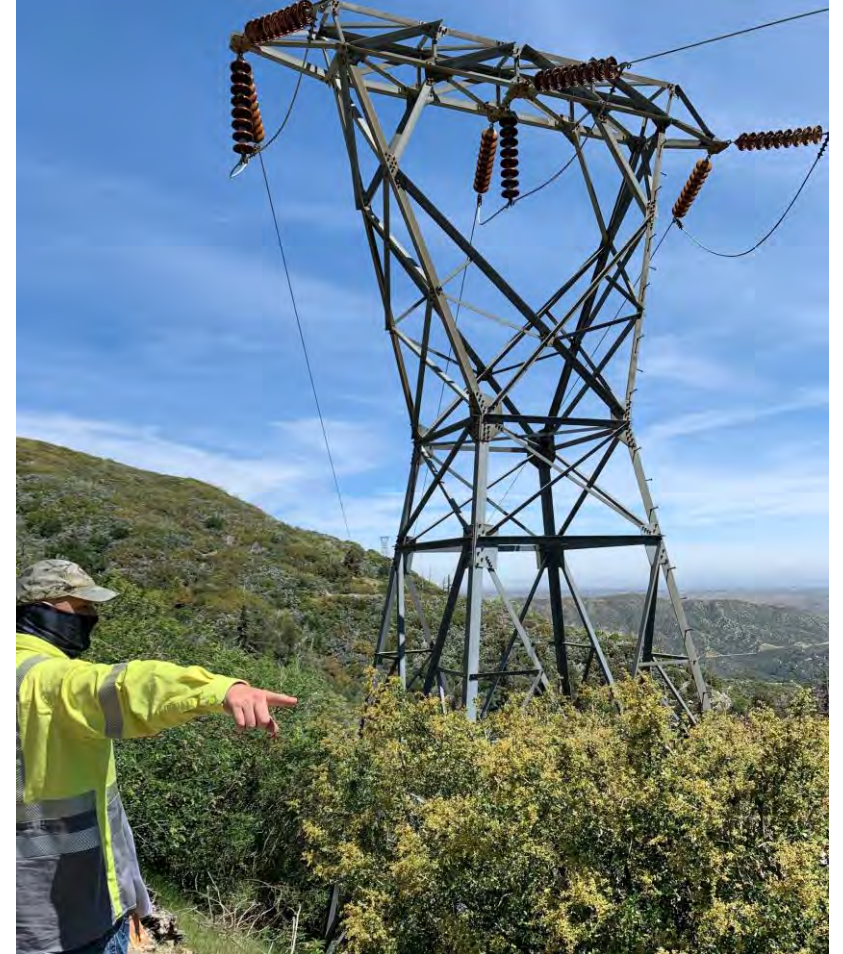
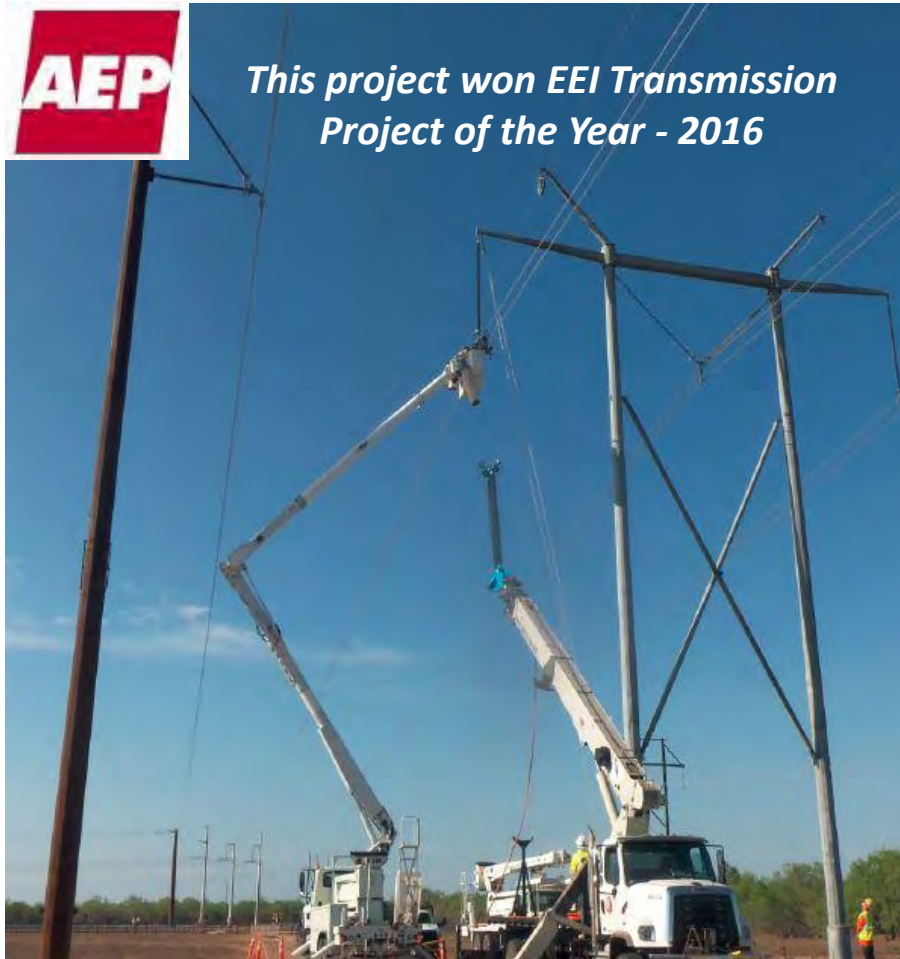
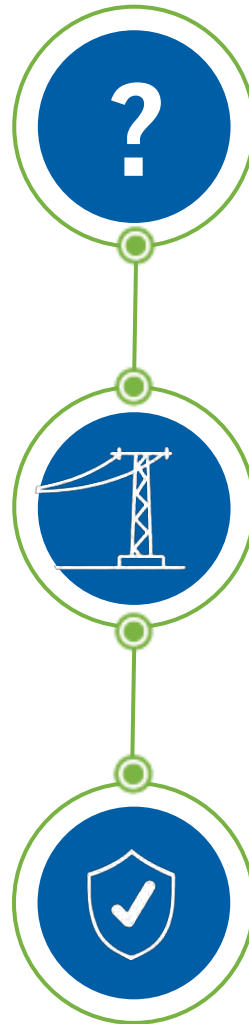
**AEP** This project won EEI Transmission Project of the Year - 2016

## Objectives

- Improve reliability (less sag and corrosion)
- Increased capacity to serve growth (**65% uprate achieved**)
- Retain existing structures – to reduce costs
- Eliminate downtime with **Live Reconductoring**

## Solution

- replace 1,440 miles of ACSR conductor with Advanced Conductor (ACCC®) w/ **live reconductor solution**
- 240 circuit miles, 345 kV line, double bundle

## Additional Benefits

- Reduced line losses by 30%
  - *Saving \$15 million/yr. (300,000 MWh at \$50)*
  - *Reducing CO<sub>2</sub> emissions by ~200,000 metric tons per year (= 43,000 cars off the road)*
  - *Freeing up ~34 MW of generation*
  - *Saving 3.5 billion gallons of water/yr. (avoided 12k gal/MWh that would have been consumed in fossil-fuel steam power plants to produce the energy saved)*

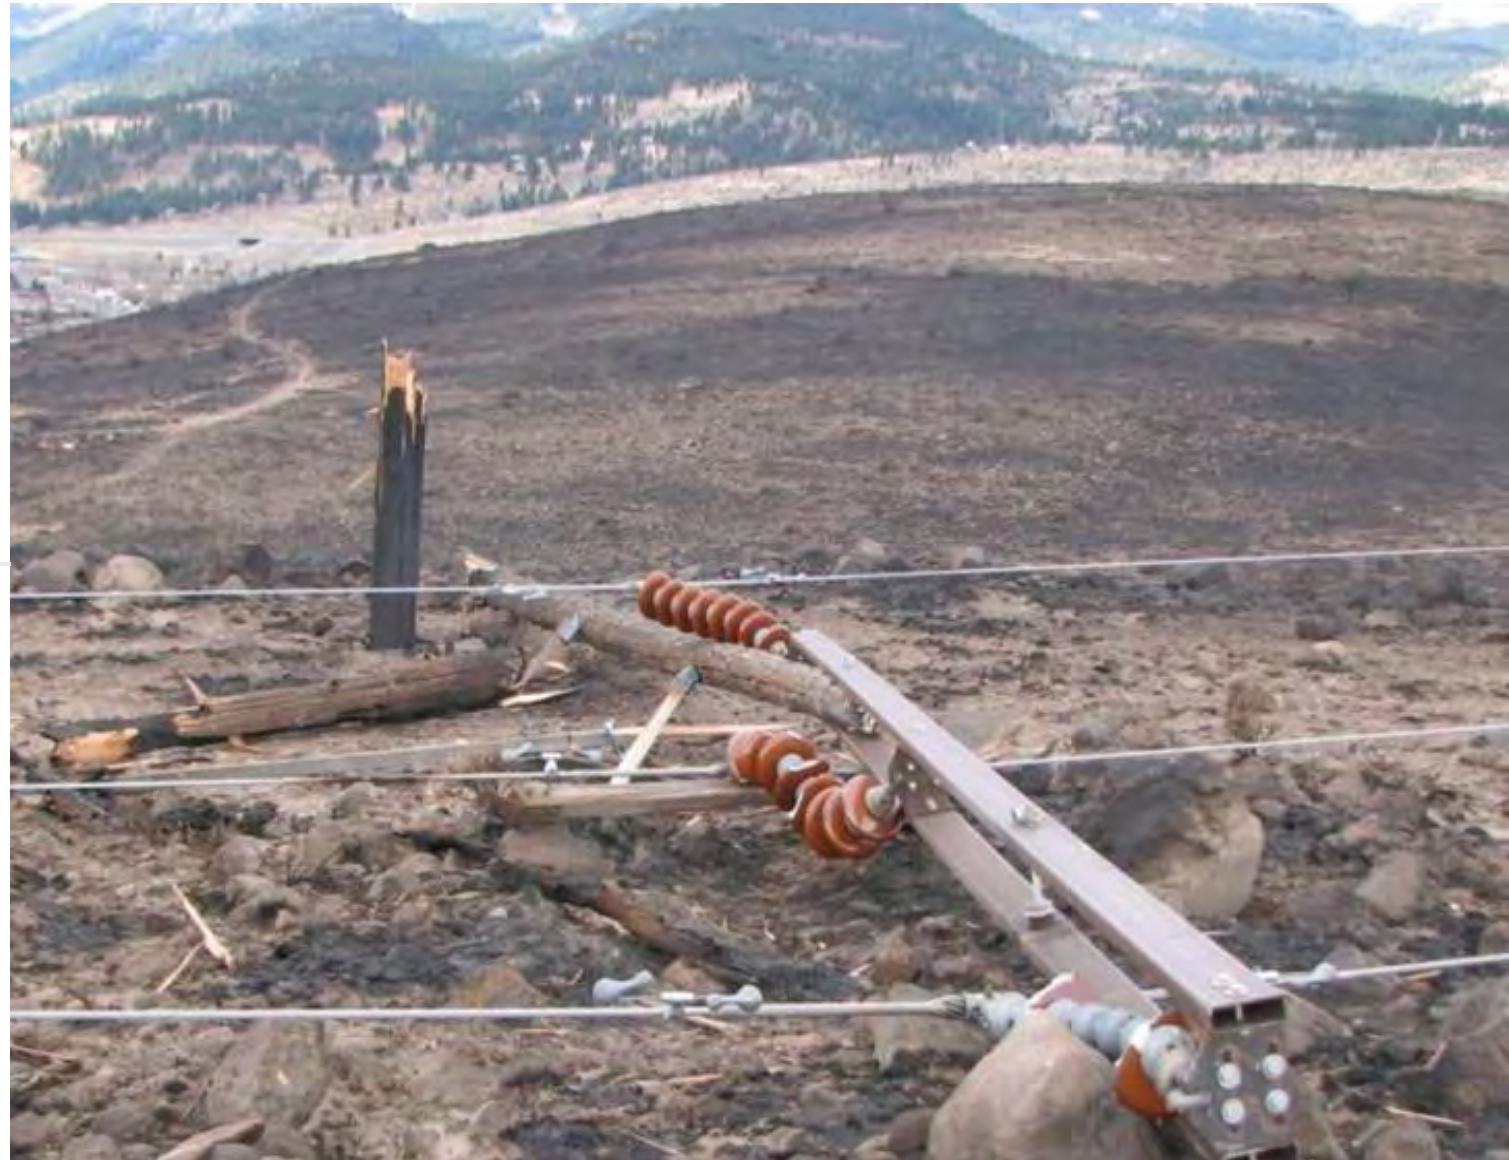
2009: ACCC<sup>®</sup> Conductor installed to increase the capacity of existing 120 kV transmission line from Reno to Carson City from 350 amps to 1,000 amps.

2012: wildfire burned down four wood H-frames structures dropping the ACCC<sup>®</sup> Conductor to the ground. The damaged structures were replaced and the undamaged ACCC<sup>®</sup> Conductor was lifted back into service.  
RESILIENCE.

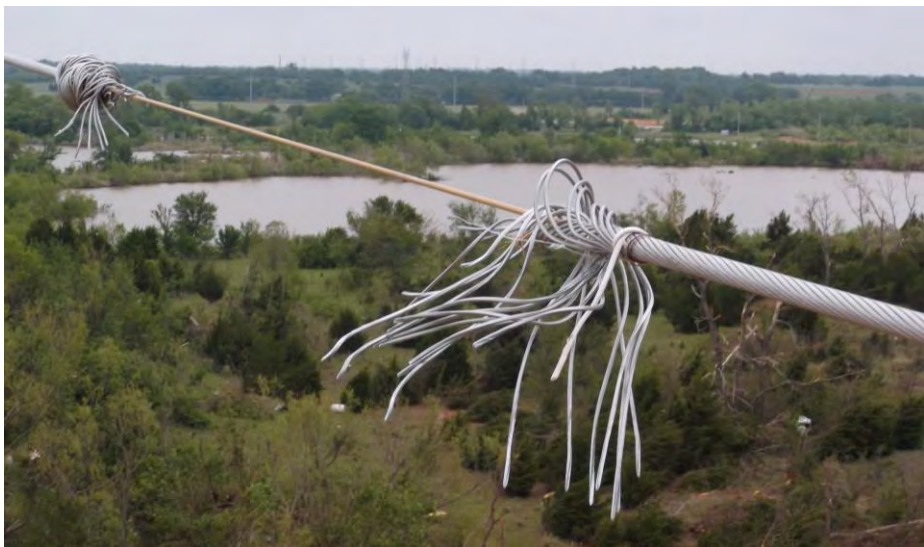
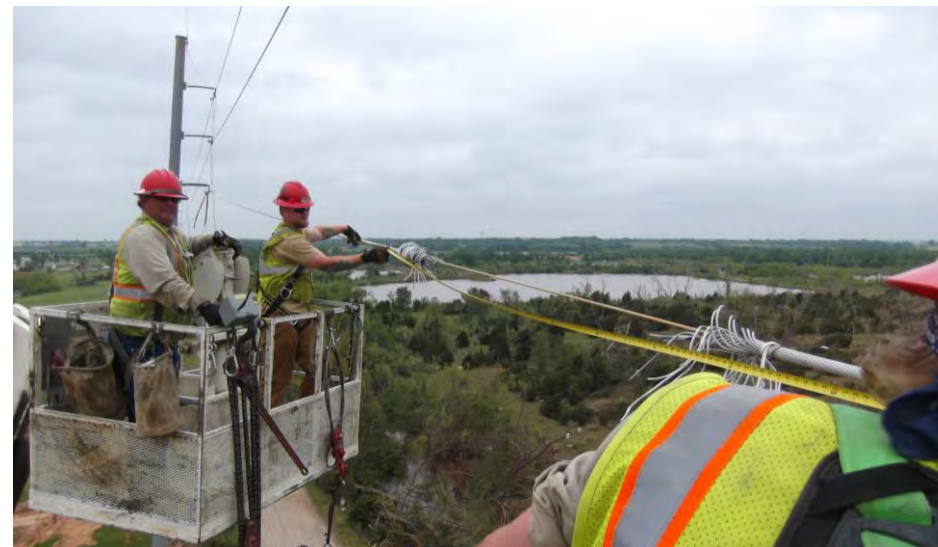
EF-5 Tornado hit Moore, Oklahoma. Tornado picked up empty shipping container and threw it into a transmission powerline steel monopole.

The shock and tension on the powerline shredded the aluminum conductor, but the carbon-composite core was NOT broken.

Because the core survived and kept the conductor in the air, the bucket crew was able to splice the conductor and return the powerline to service after only a few hours.
